Demonstration of Smart Fluorescent and Self-Healing Coatings for Severely Corrosive Environments at Vehicle Wash Facilities

Final Report on Project FAR-02 for FY06

August 2009

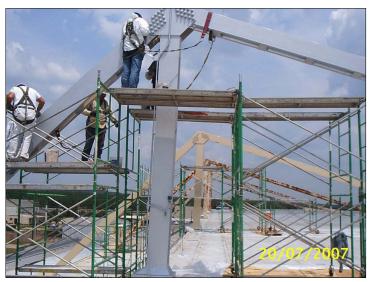
Figure 1. Overcoating the hanger superstructure (working from scaffolding and appropriately tied off).

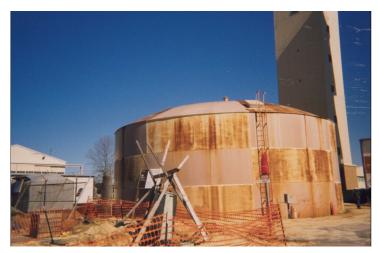
Figure 2. Deluge Tank No. 2 before painting.

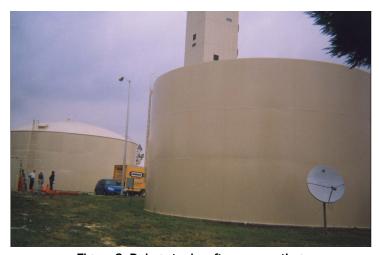
Figure 3. Deluge tanks after overcoating.

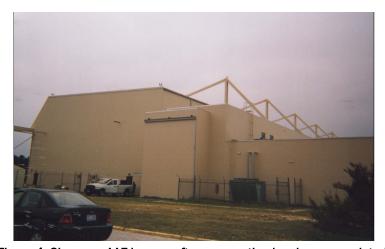
Figure 4. Simmons AAF hangar after overcoating has been completed.

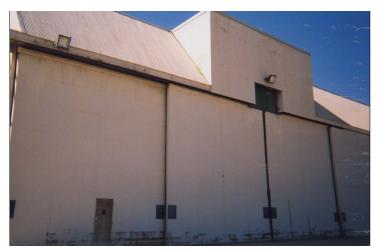
Figure 6. Simmons AAF hangar before painting.

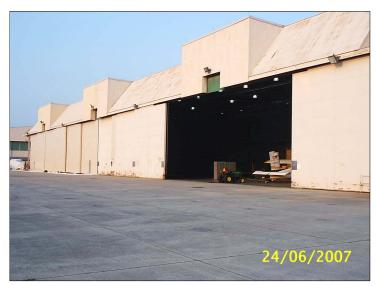
Figure 7. Simmons AAF hangar before painting.

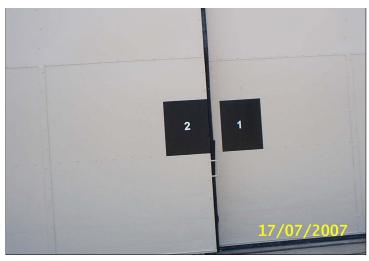
Figure 8. Simmons AAF hangar doors after overcoating.

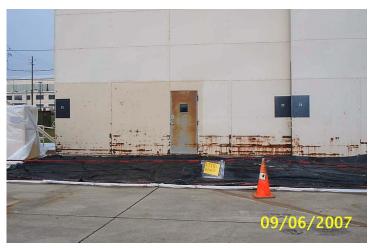
Figure 9. Simmons AAF hangar before painting.

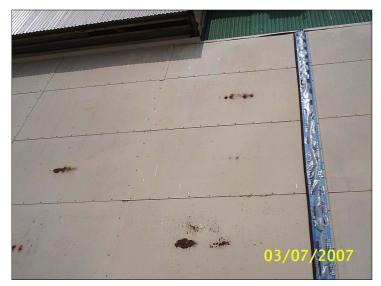
Figure 10. Simmons AAF hangar before painting, showing masking of utility line.

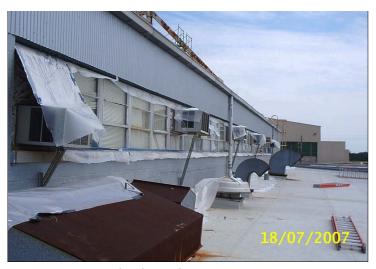
Figure 11. Simmons AAF hangar after first MCU coat, showing protective covers and masking.

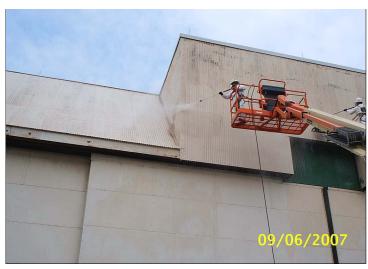
Figure 14. Simmons AAF hangar during power washing to remove dirt, chalk, and loose paint.

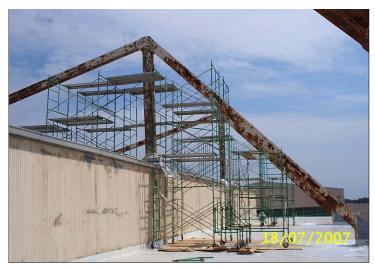
Figure 15. Simmons AAF hangar before overcoating. Note the extent of rust on the steel superstructure and metal siding.

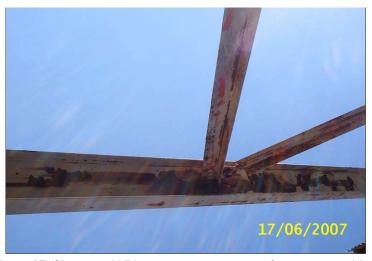
Figure 17. Simmons AAF hangar superstructure after power washing.

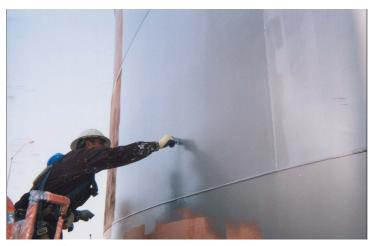
Figure 18. Inspecting the paint thickness on a deluge tank.

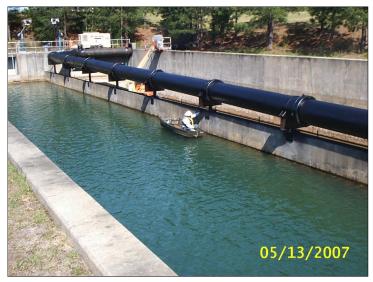
Figure 19. Smart coatings on pipe at CVWF grit basin.

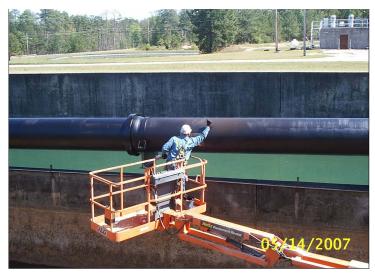
Figure 21. Applying smart coating system to pipe.

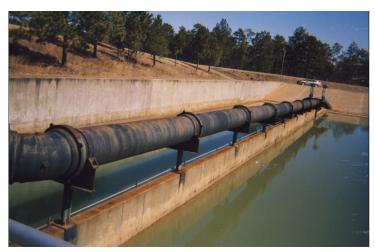
Figure 24. Pipe before abrasive blasting showing corrosion.

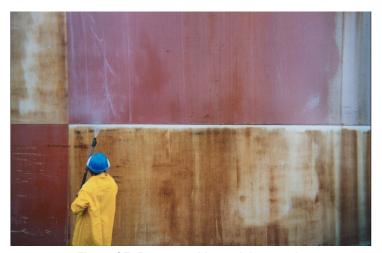
Figure 25. Power washing a deluge tank.

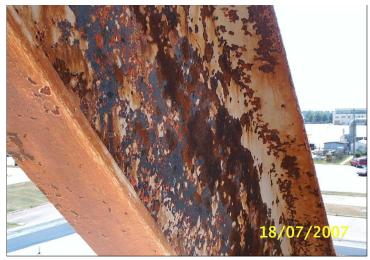
Figure 28. Condition of hangar superstructure before work began.

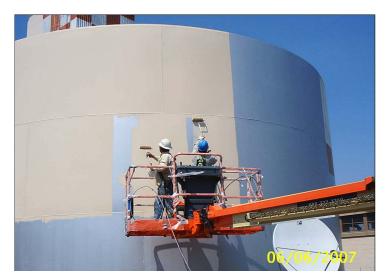
Figure 31. Applying aliphatic polyurethane topcoat to deluge tank.

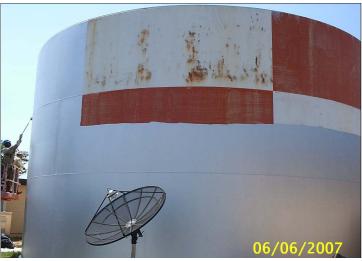
Figure 32. Work in progress showing the overcoat primer, an MCU (Rust Grip).

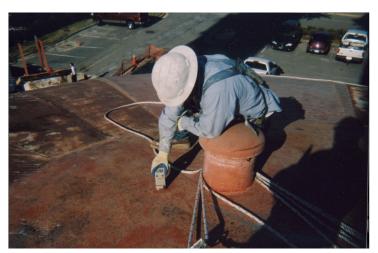
Figure 35. Inspecting the deluge tank paint thickness before starting work.

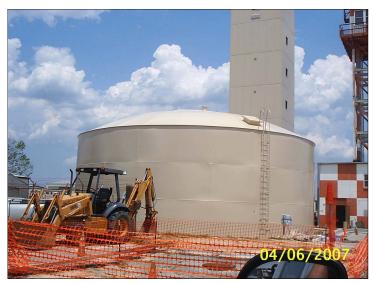
Figure 36. Deluge tank with newly completed overcoat system.

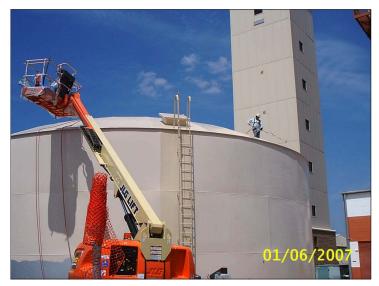
Figure 37. Applying topcoat to tank roof using a power roller. All work was performed by brush and roll to prevent overspray damage to vehicles and facilities.

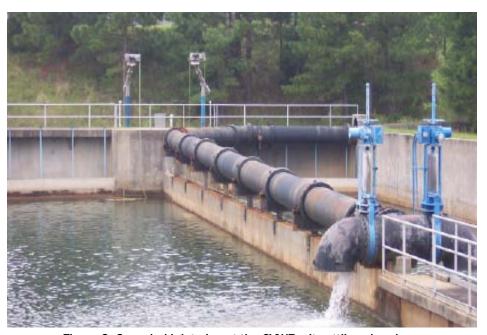
Figure 2. Corroded inlet pipe at the CVWF grit settling chamber.

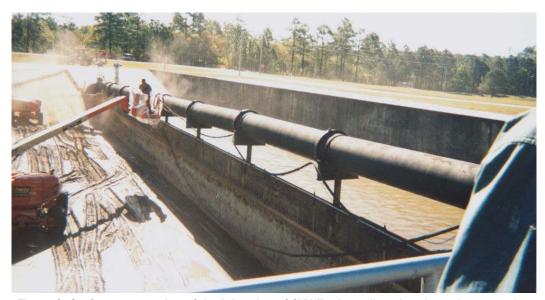
Figure 9. Surface preparation of the inlet pipe of CVWF grit settling chamber prior to coating with smart coatings.

Cleaning and Surface Preparation	Pressure Wash to remove surface contamination at 1,500 to 4,000psi. Abrasive blast to Near White Metal SSPC10		
Environmental Controls	Impermeable ground tarps, or plastic		
Primer	Coal Tar Epoxy 78HB with Fluorescent additive; two coats at 75 00 microns dry thickness/coat		
Primer at Critical Areas	Coal Tar Epoxy 78HB with Microcapsule additive; one coat at 75 to 100 microns dry film thickness		
Finish Coat	Coat Tar Epoxy 78HB; two coats at 75 to 100 microns dry thickness/coat

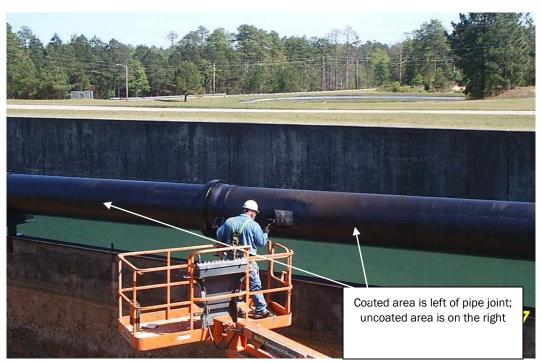
Figure 11. Inlet pipe of CVWF grit settling chamber being coated with coal tar epoxy that with self healing and fluorescent additives.

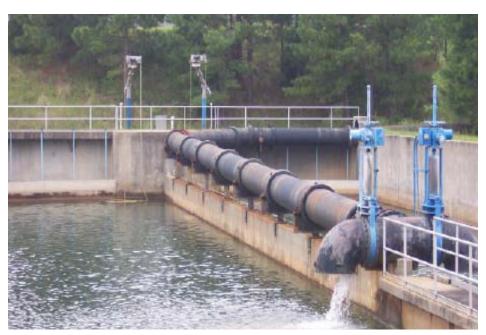
As noted in the Manta reports, surface rust was present over approximately 60% of the pipe exterior (see Figure G1). Coating mil thickness had degraded to a point exposing steel to environment and further corrosion. Existing coatings in critical areas such as welds, elbows, couplers, bolts and pipe stands exhibited signs of cracking, peeling and corrosion. Severe chalking was also occurring. The Manta project lab analysis of existing coating material identified "lead" levels below action levels. Appropriate action was taken to contain and properly dispose of the contaminated waste per local, state, and federal requirements.

Figure G1. CVWF inlet pipe, May 2007.

The Manta test cadre water blasted, abrasive blasted, primed and painted the CVWF inlet pipe in May 2007. Specific coating preparation and appli-
